WALKING TOUR PHOTOS

Wednesday, February 22, 2023

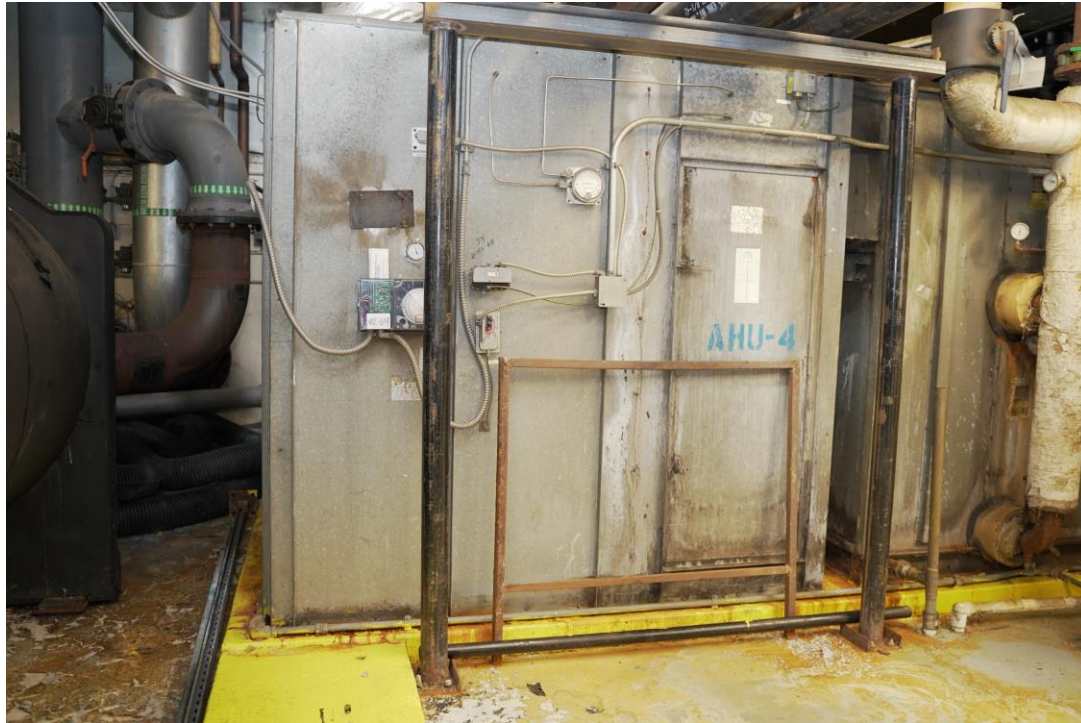
Air Handler for Trauma OR and Trauma ICU's

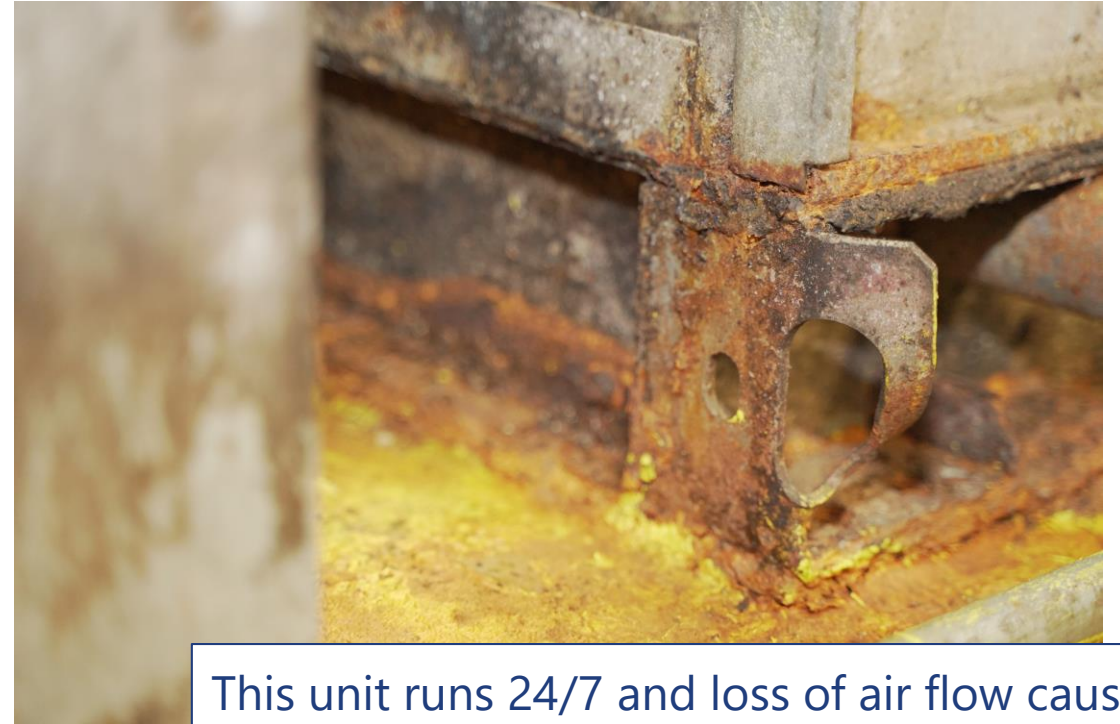
Deterioration on system supports.

This unit runs 24/7 and loss of air flow causes the trauma center to go on diversion until system is restored.

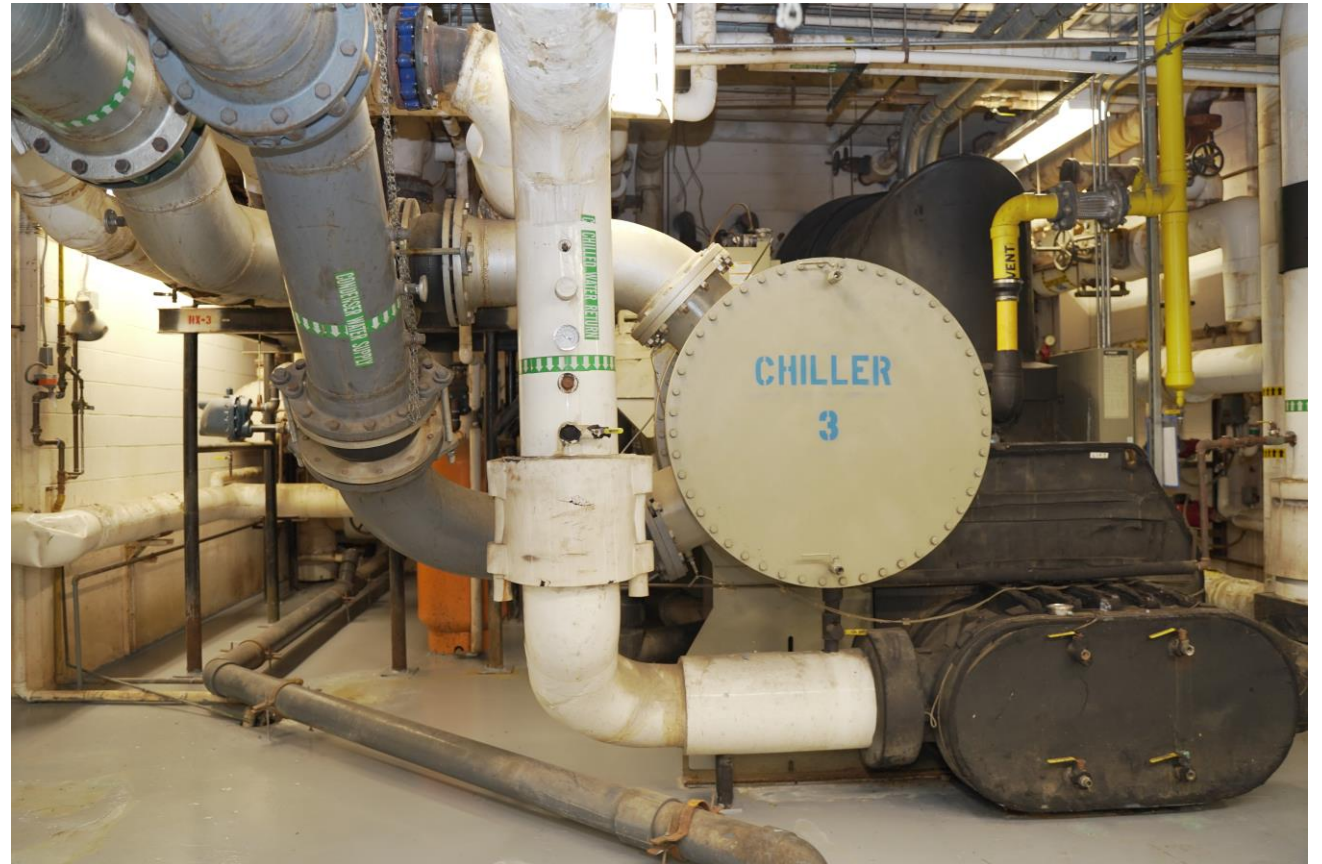
This is one of four chillers providing cool air to the hospital. It has exceeded useful life. Currently, to maintain *normal* cooling, we must run 3 of our 4 chillers at all times. *Peak* load requires all four chillers to cool the complex. There is no redundancy in this system and during loss-of-power events they are not on emergency power.

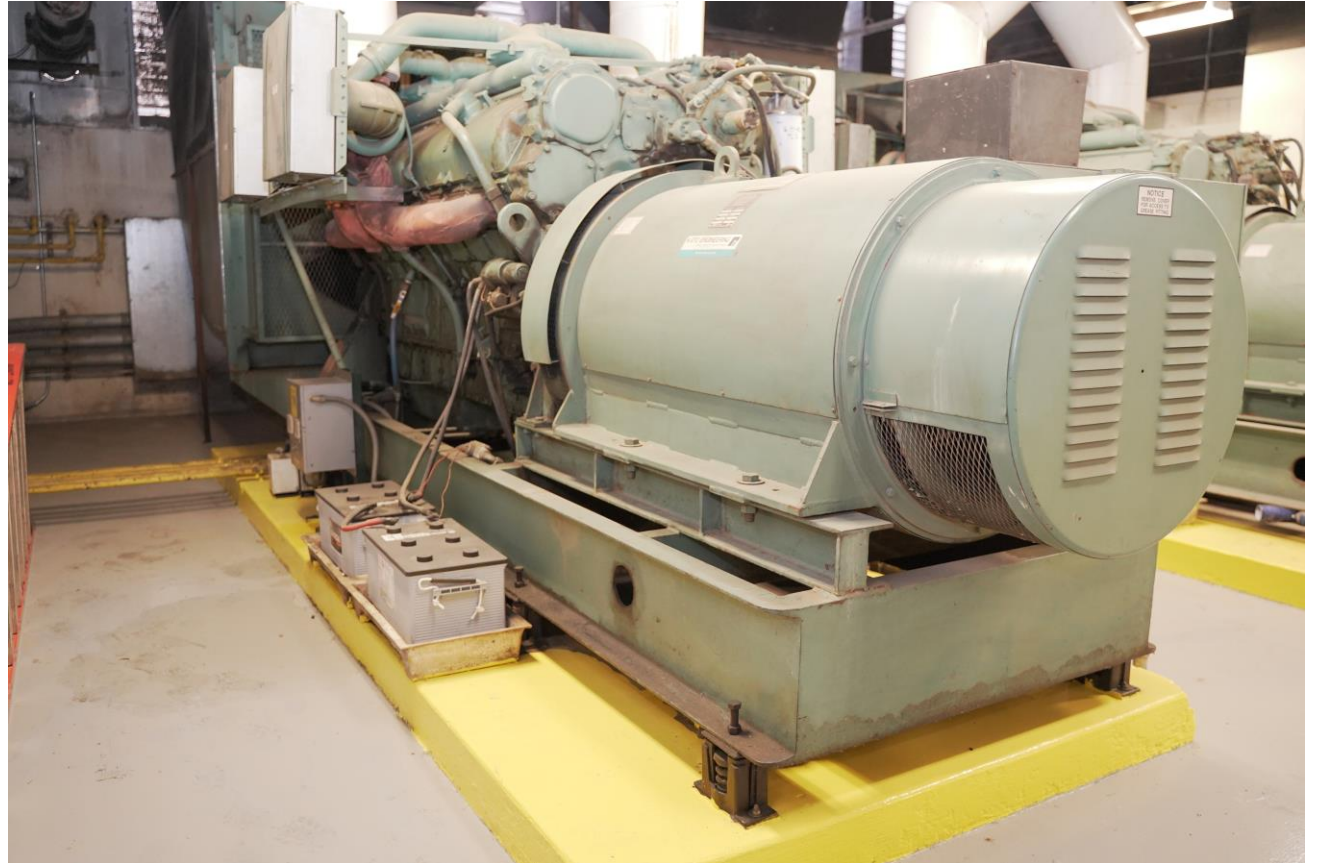
The Jefferson Building has two generators, and no redundancy. Load shedding is necessary if we have a failure.

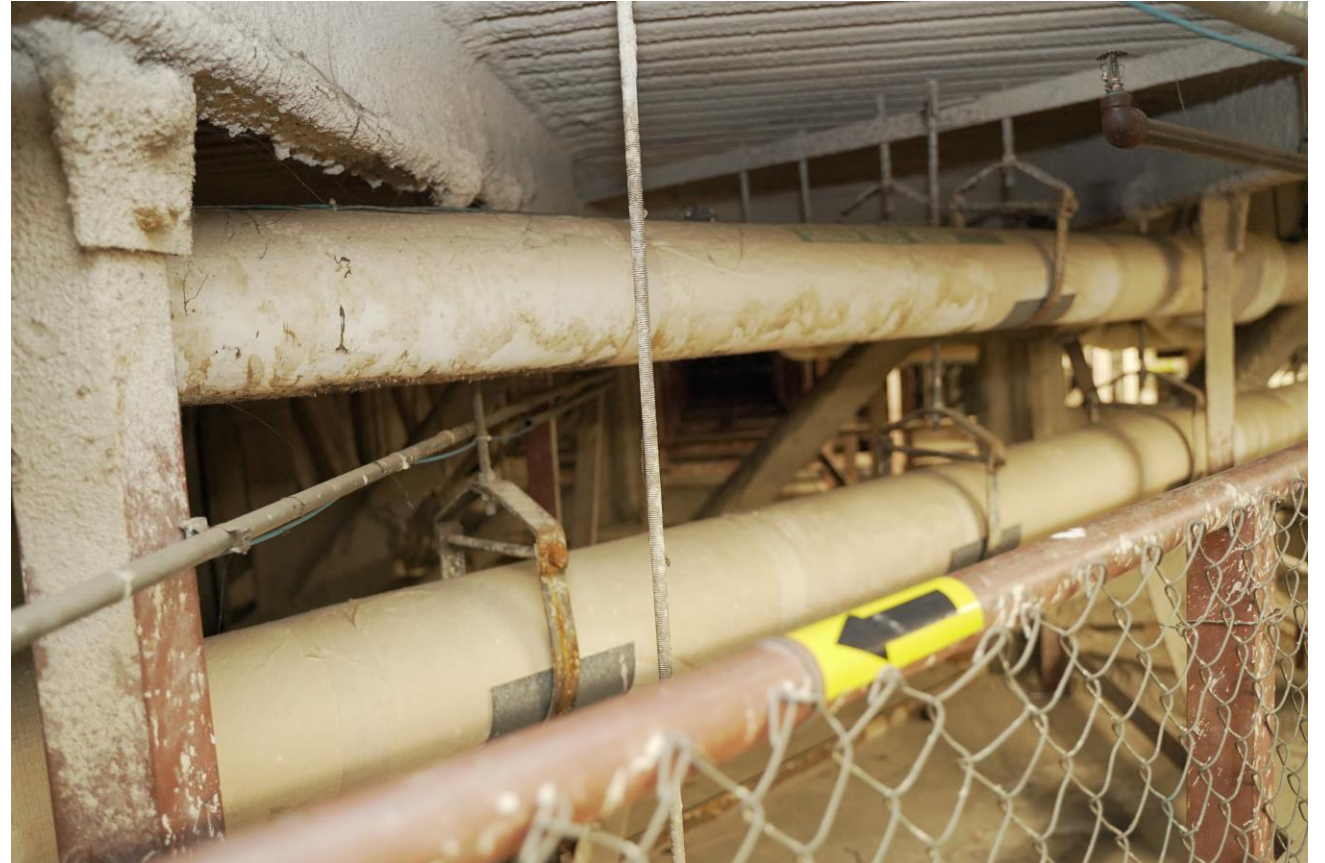
Mechanical interstitial space in the Jefferson Building contains air handlers for portions of the building. They are not easily accessible, making swapping out motors and other heavy items problematic.

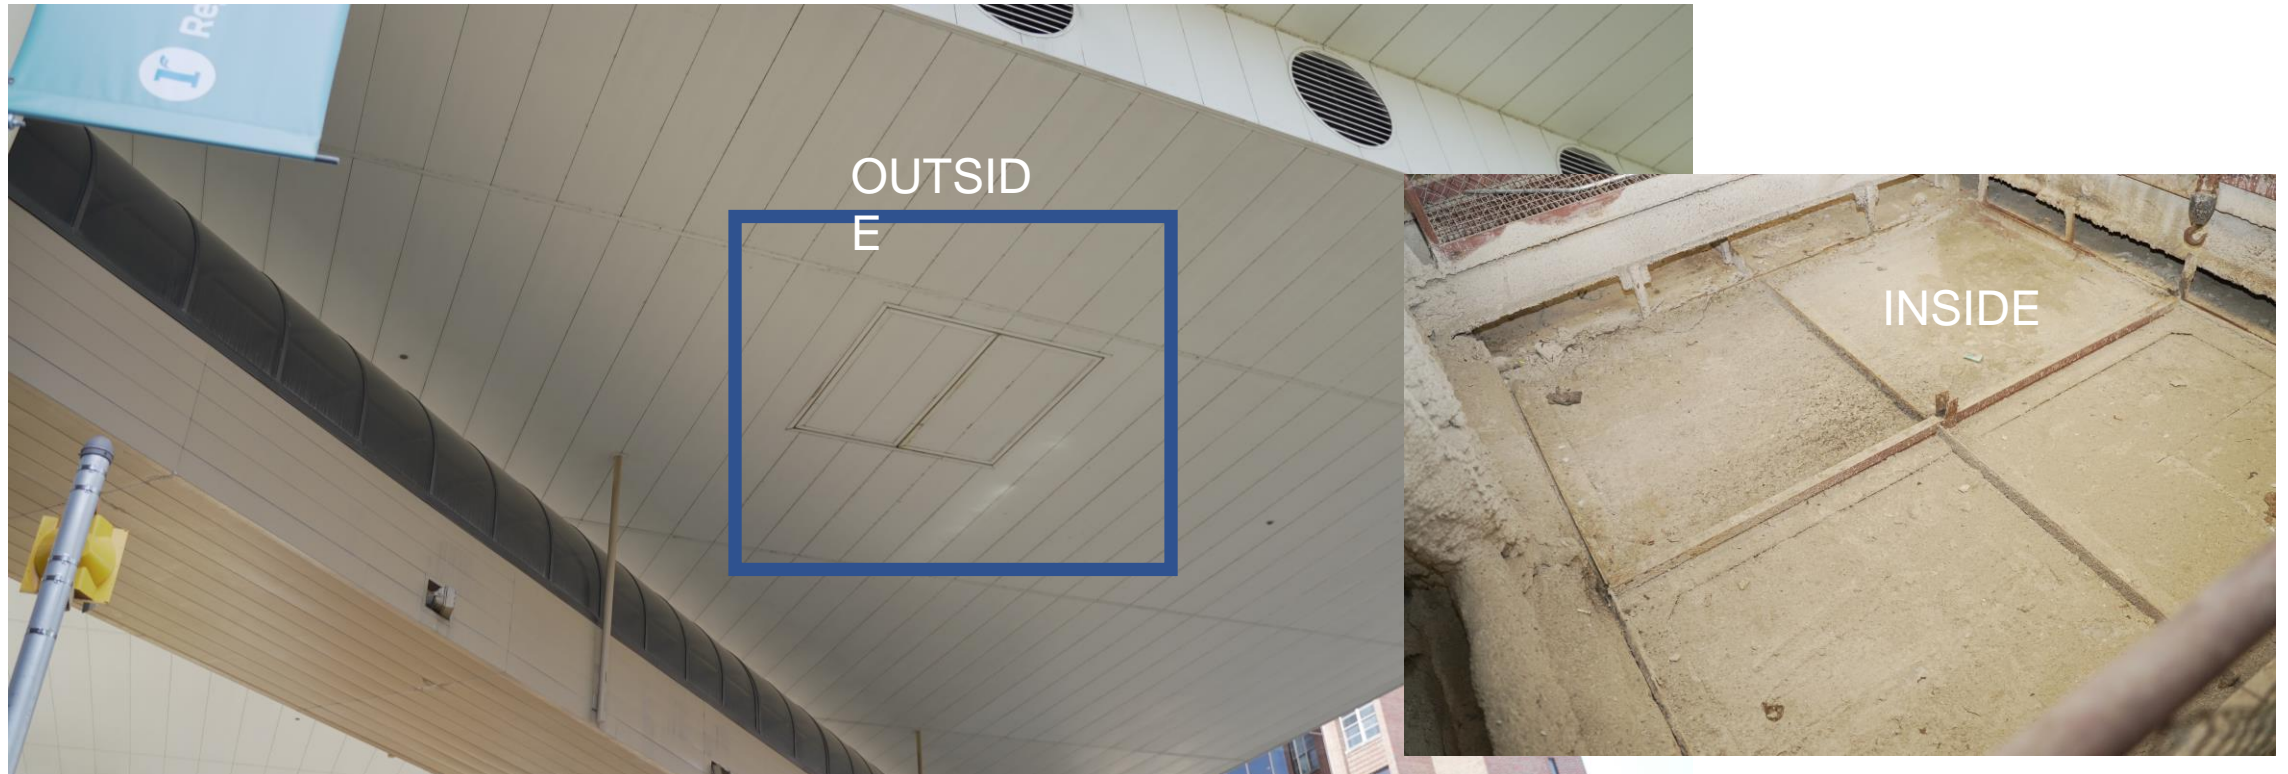
Location of the 40 foot drop pictured in the previous photo.

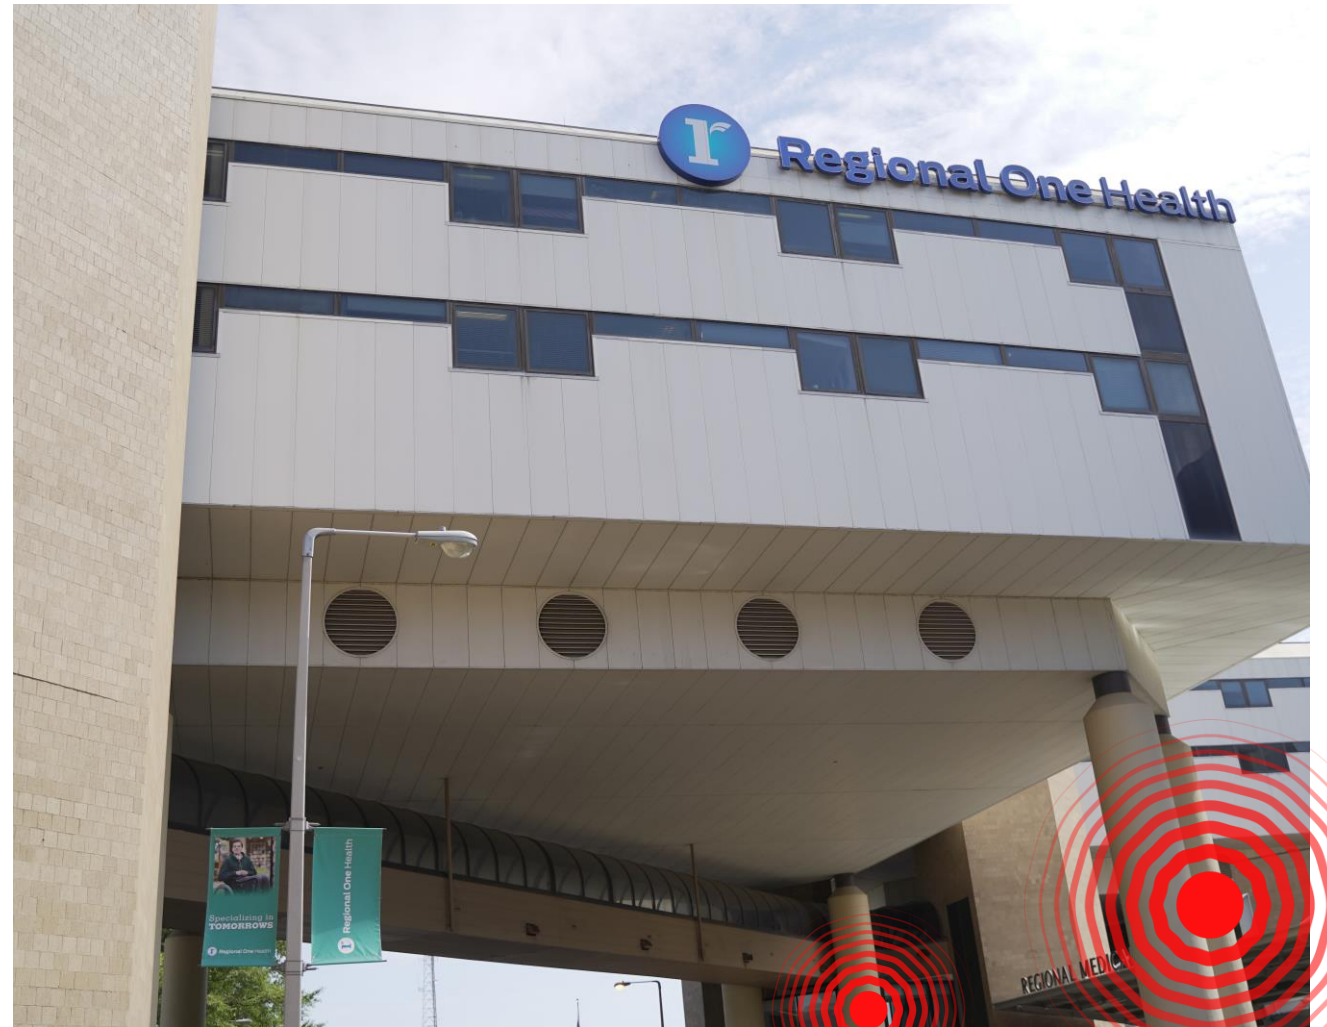
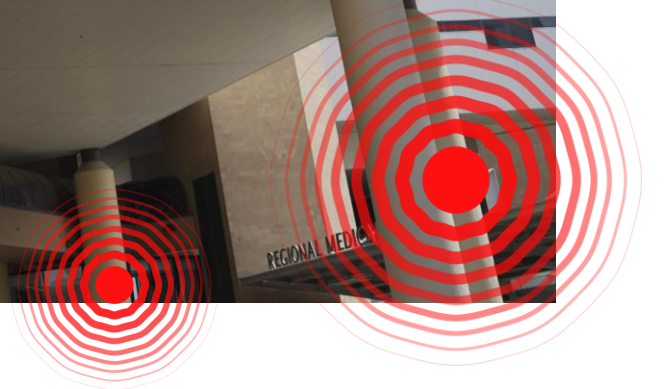
It is expected that under the target seismic events that either the partial or total collapse of the building will occur. This is detailed further in the 2022 A2H Engineering seismic study.

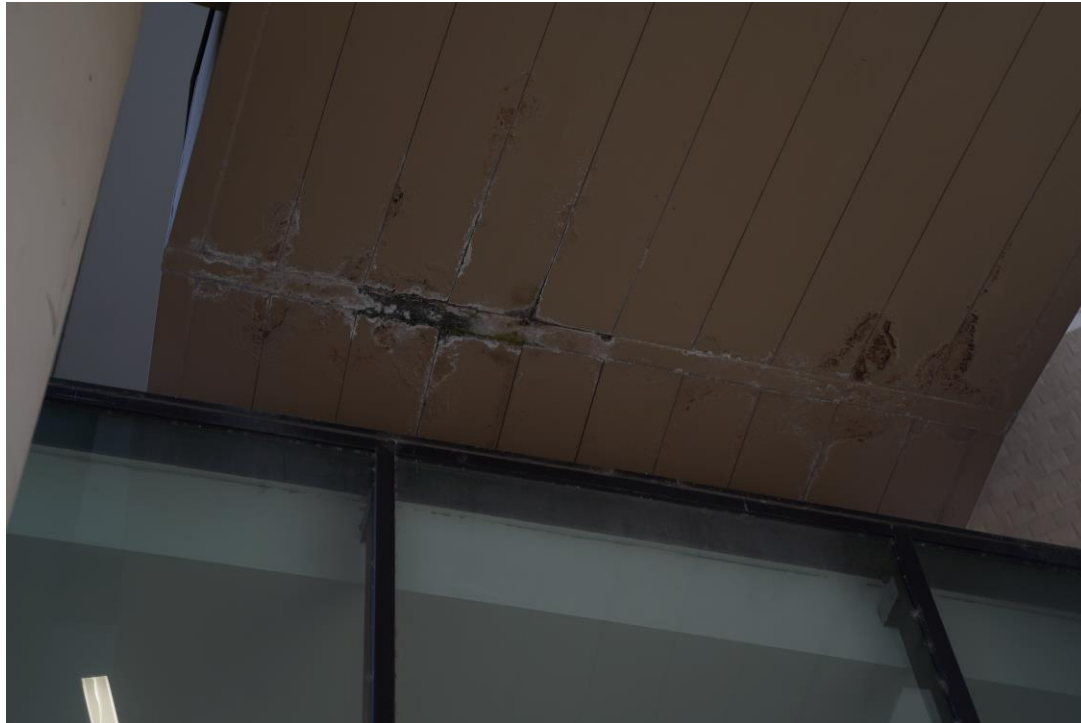
Deterioration of exterior panels

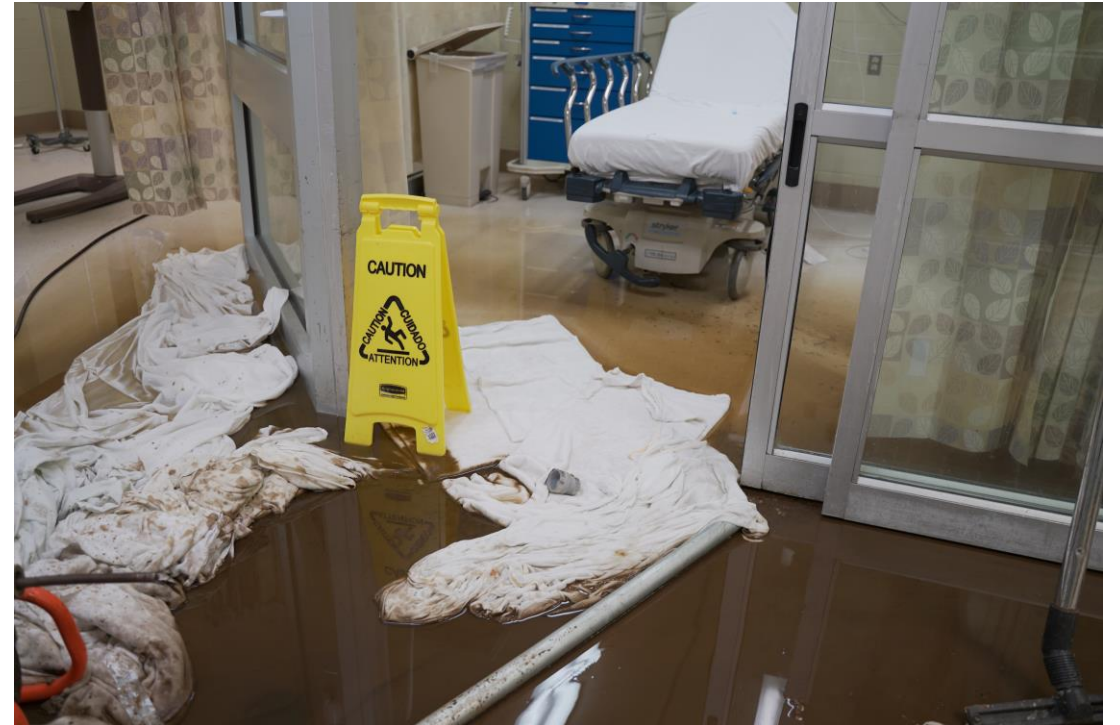
Plumbing system issues resulted in raw sewage in patient care space.

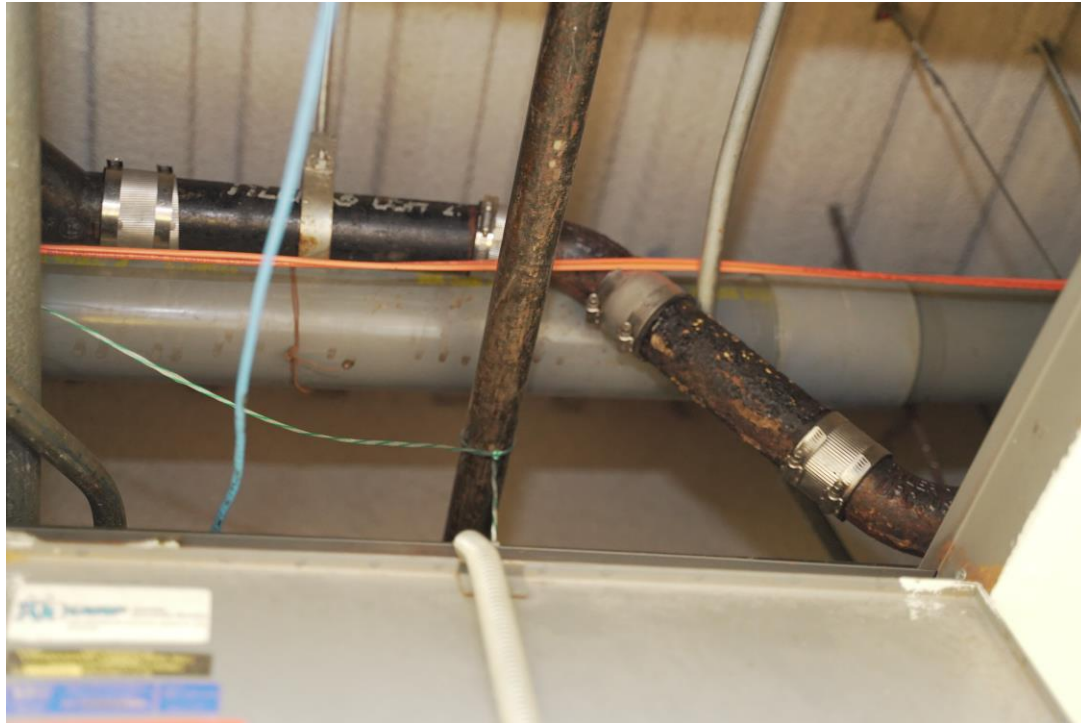
Plumbing system piping used throughout Jefferson Building has exceeded useful life.

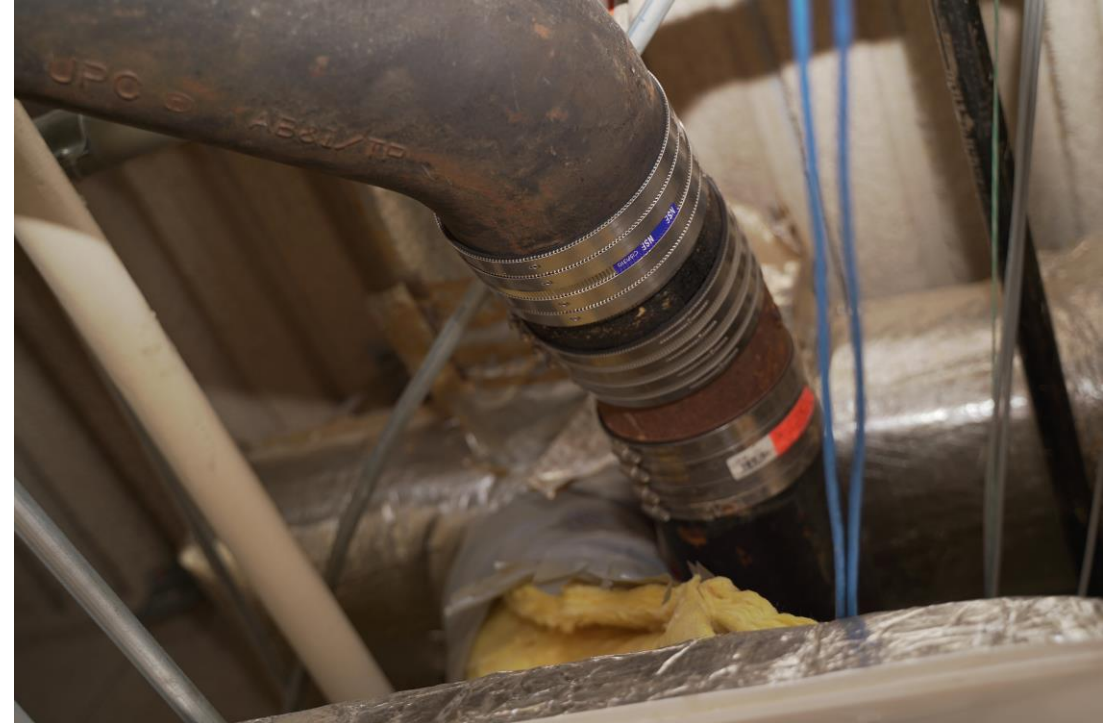
Further, this piping is prone to issues such as cracking due to outdated manufacturing processes.

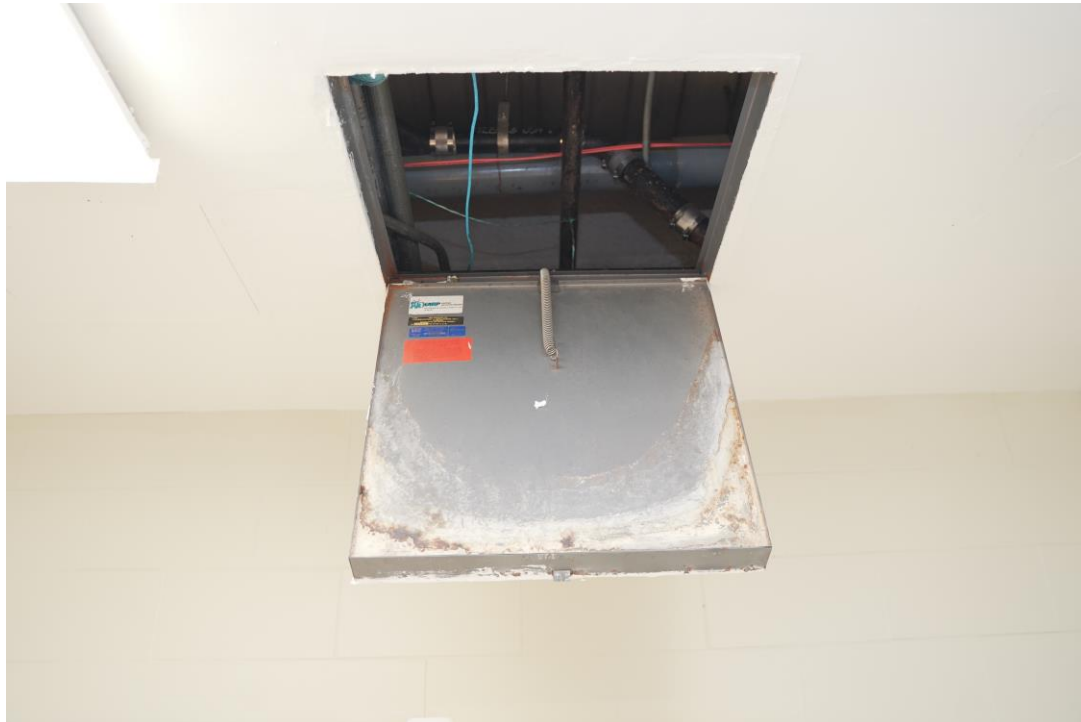
Limited access makes even the most basic of repairs more time consuming and more costly.

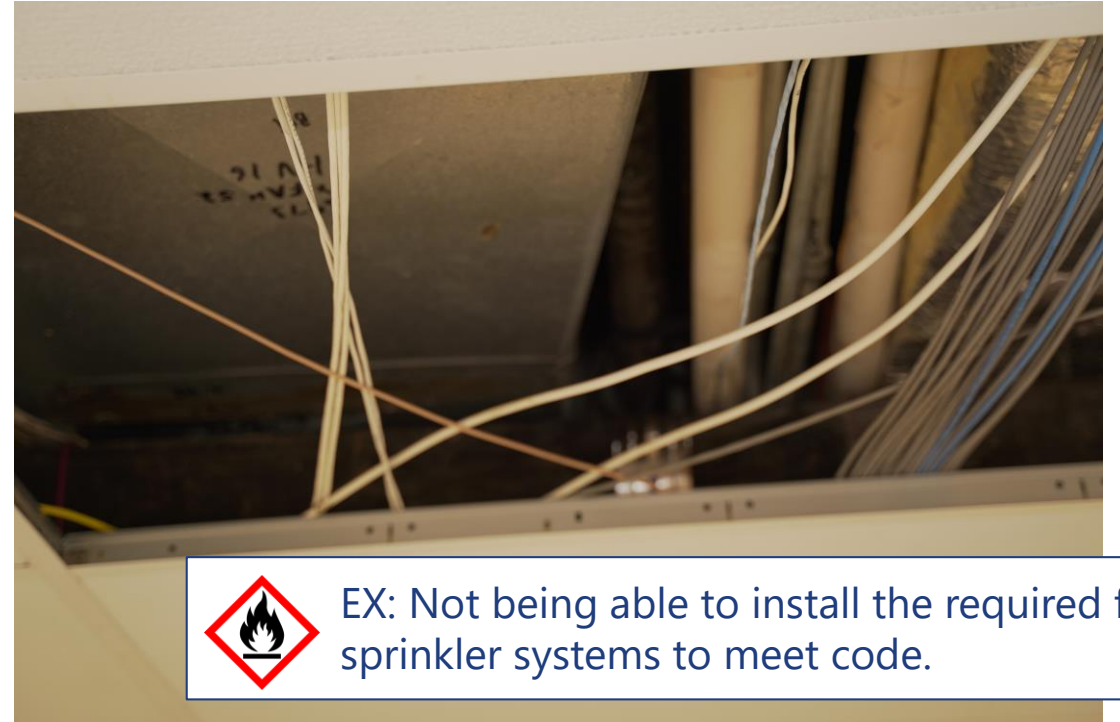
Limited space between floors prohibits successful renovation due to lack of available space for more modern building systems.

EX: Not being able to install the required fire sprinkler systems to meet code.

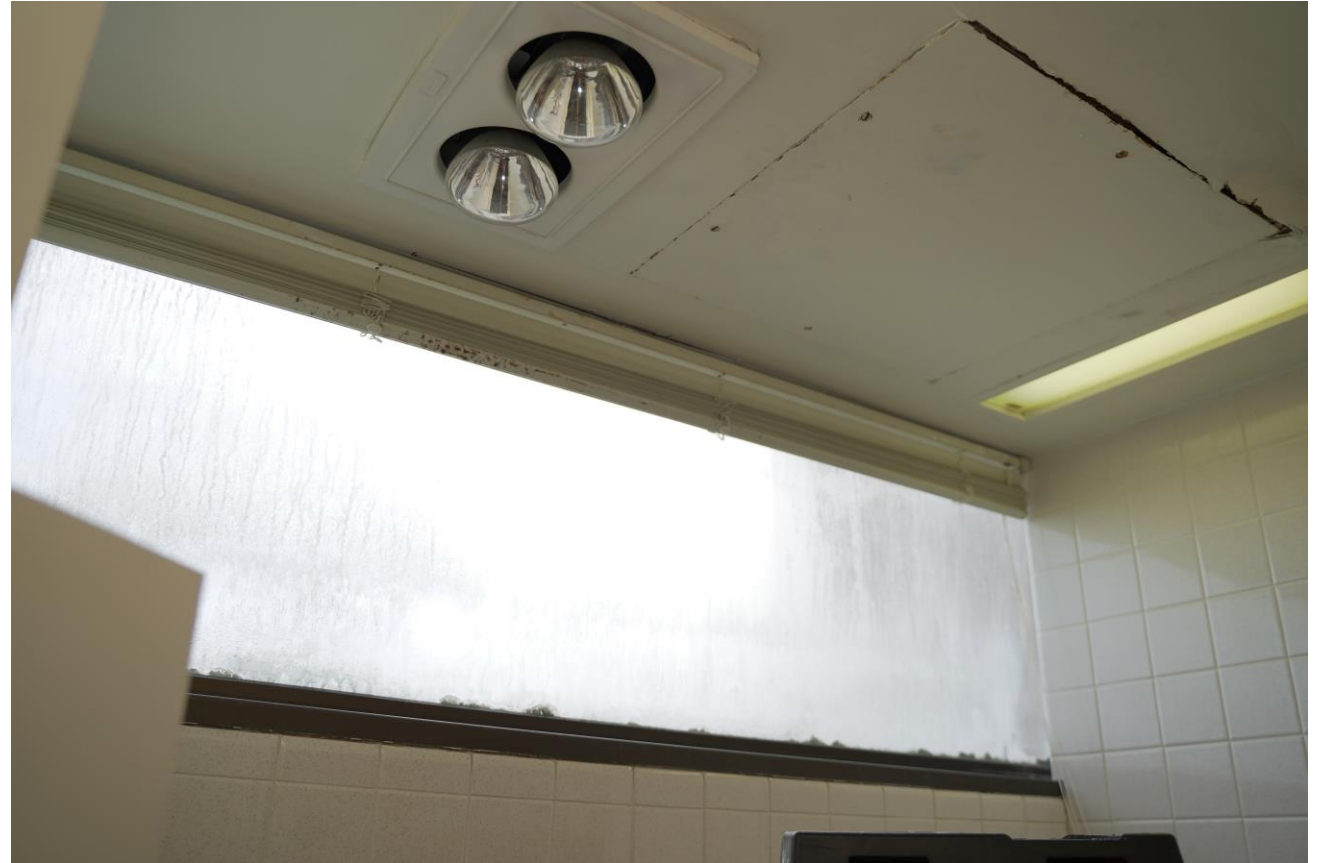
Windows throughout the Jefferson Building are past end-of-life. Gaskets between panes of glass have failed, compromising the building envelope.

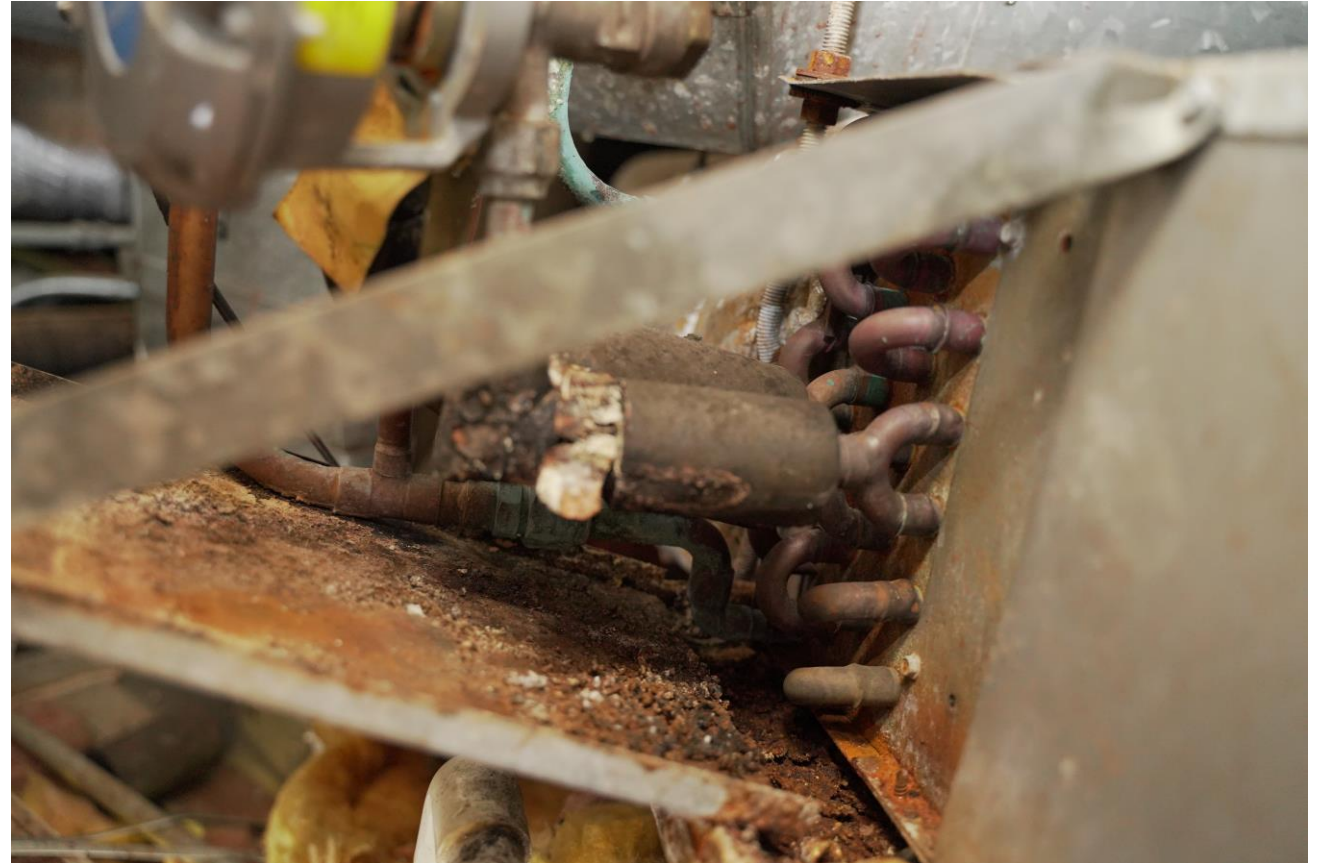
Each patient room in the Jefferson Building (4th and 5th floors) has its own individual fan coil unit. These units have exceeded their useful life and have severely deteriorated. Again, space above the ceiling is very limited which restricts access to service the unit.

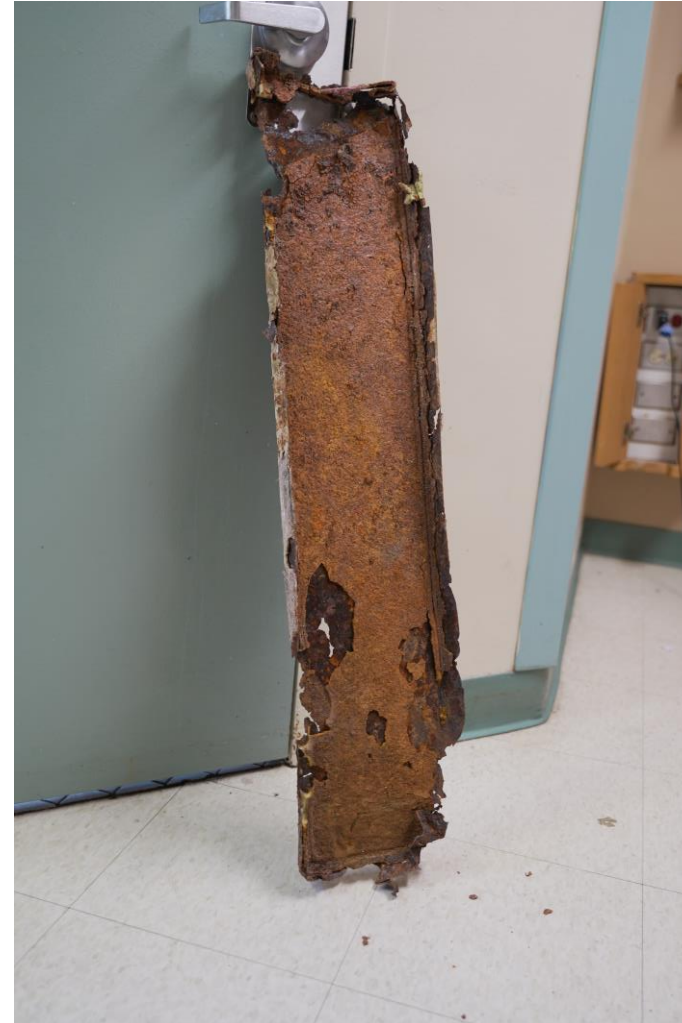
Example of rusted out drain pan in
patient room fan coil unit.

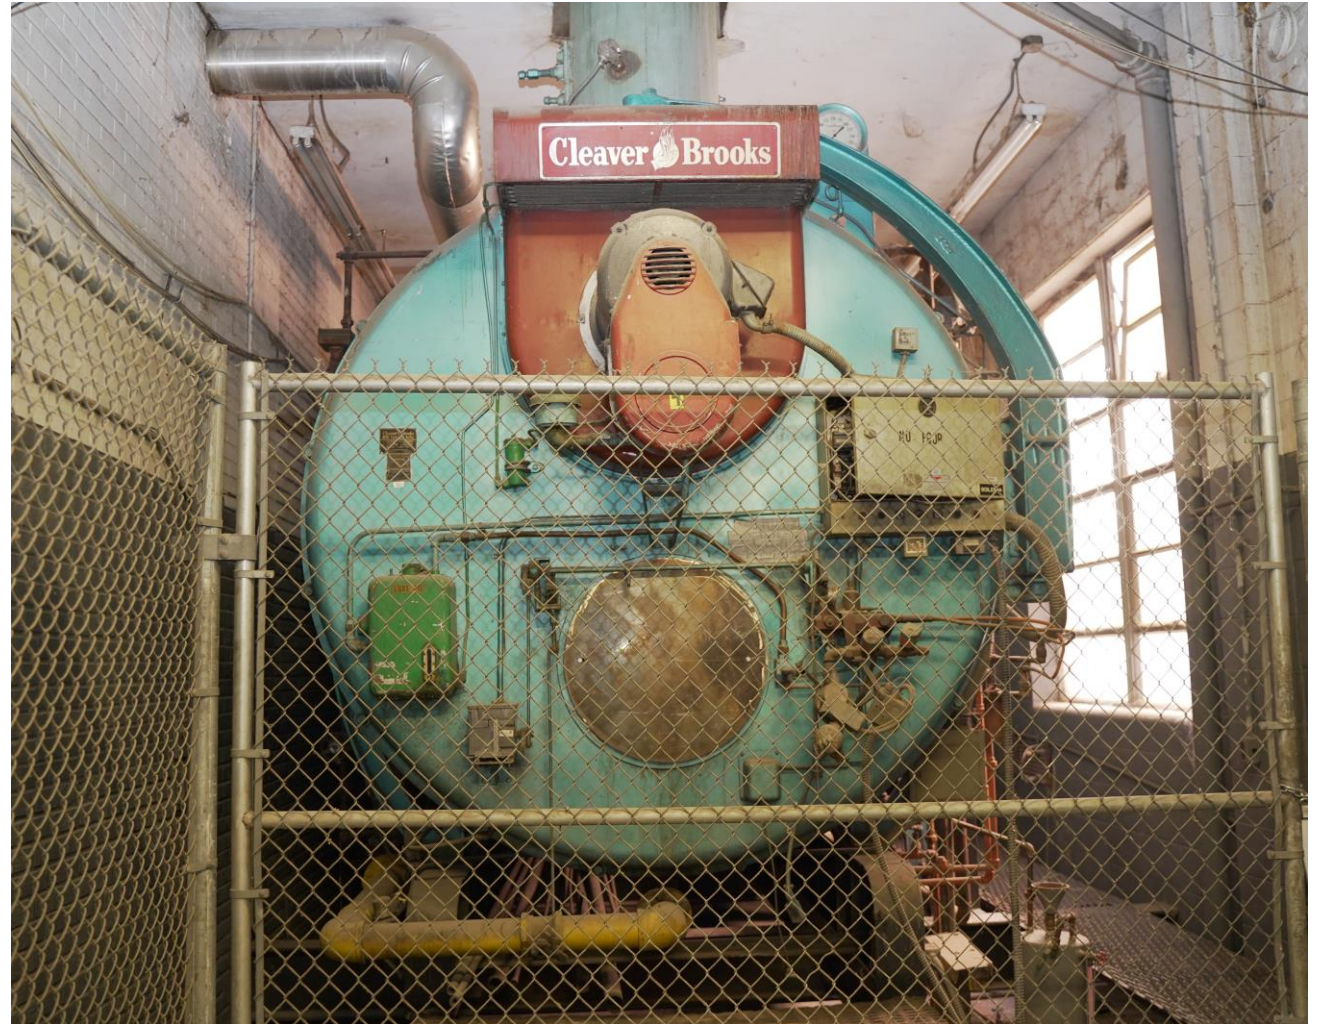
Old boiler abandoned in place. No way to remove without demolition of surrounding walls and cutting of access to other support space.

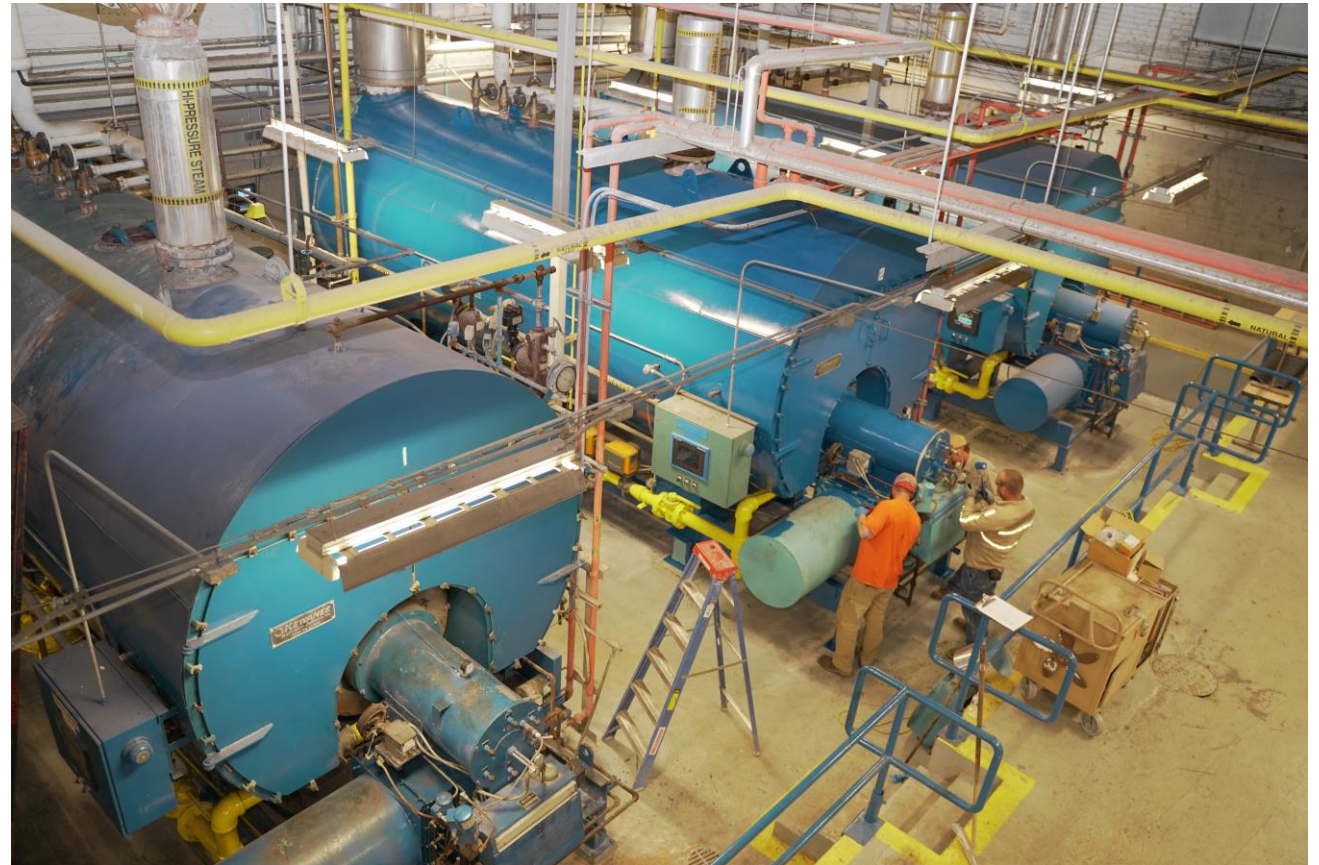
The remaining high-pressure boilers are not only obsolete, they have exceeded useful life and the manufacturer is no longer in business. Replacement of this equipment would require complete system shutdown. Each unit is located under layers of piping, equipment and electrical conduits. The building that houses them is not seismically rated.

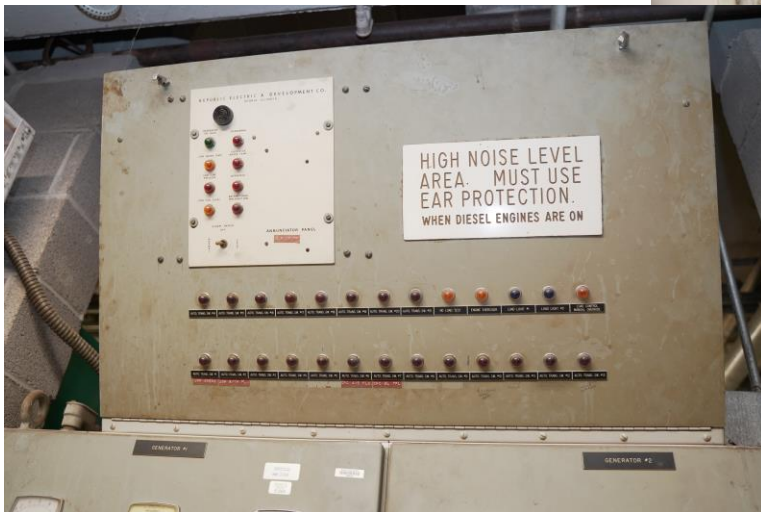
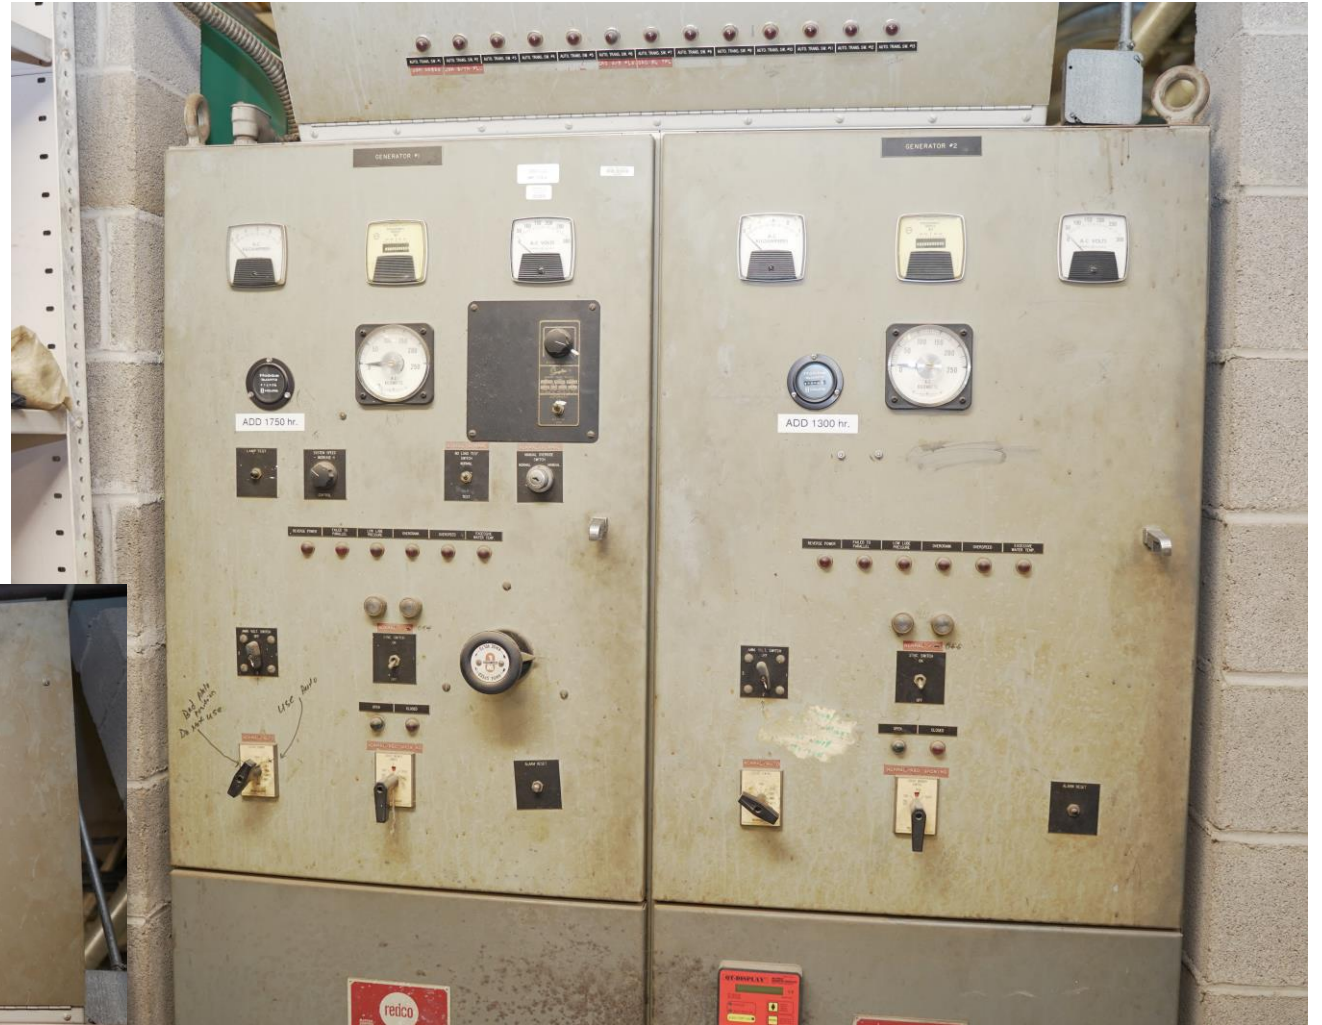
Early 1960's instrumentation and controllers for boiler room emergency generators.

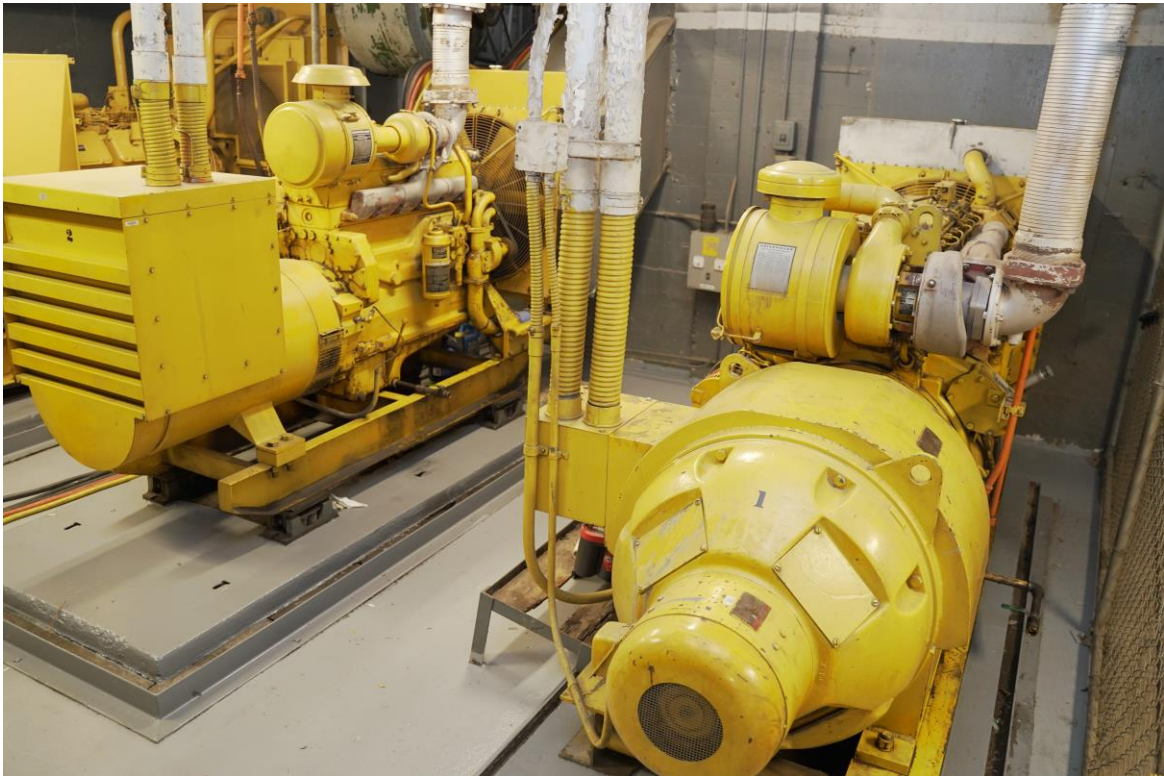
Boiler room generators
